UPDATED CAPITAL RESERVE ANALYSIS
FOR
FOXWOOD HILLS
WESTMINSTER, SOUTH CAROLINA

FOXWOOD HILLS PROPERTY OWNERS ASSOCIATION, INC.
800 Hickory Trail
Westminster, South Carolina 29693

AUGUST 2023

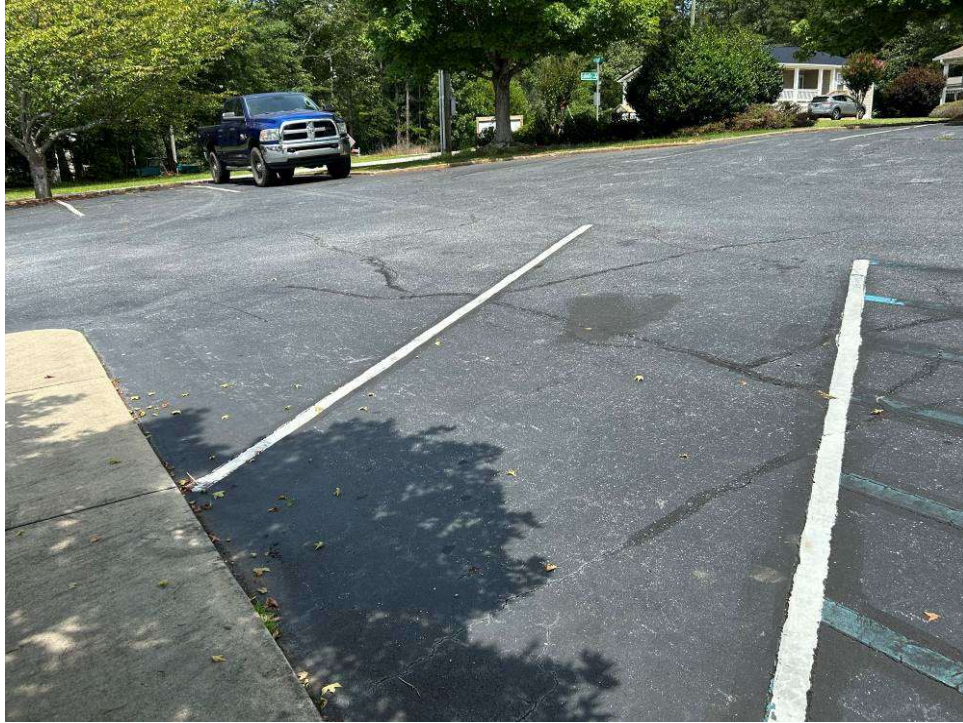
1. These items were found to be in good condition and well maintained. The useful life reflects the age and overall condition of the respective item.
2. **Private Roads/Parking Areas** – The asphalt roads and parking areas appear to consist of a graded aggregate base, asphalt base course, and asphalt surface course other than Homestead which consists of a graded aggregate base. The perimeters of the parking lot are surrounded by concrete curbs and gutters. It is our understanding that work was done to some of the private roads in 2021 and 2022 amounting to \$84,000 and \$495,000 respectively. From our review, the asphalt pavement appeared to be in generally good to fair condition for its age and experiencing normal wear and tear. It should be noted that we did observe linear cracks in the asphalt (reference photographs 1-3). Most of the cracks observed appear to be the result of normal wear and tear.

1. View of linear cracks at clubhouse parking lot.

In order to prolong the useful life of the asphalt pavement, we recommend that the cracks be filled, and the pavement be sealcoated and striped every six to eight years. The useful life of asphalt pavement is approximately 20 years, after which, a new layer of asphalt should be installed. Prior to overlay, any settled areas should be removed, the base then re-compacted, and a new layer of asphalt course installed. It is recommended that a budget be allocated for the resurfacing of the asphalt with a 1-1/2" mill and overlay every 20 years. We recommend that the asphalt surface be inspected approximately every ten years to determine if the condition of asphalt is adequate and if the useful life can be prolonged.

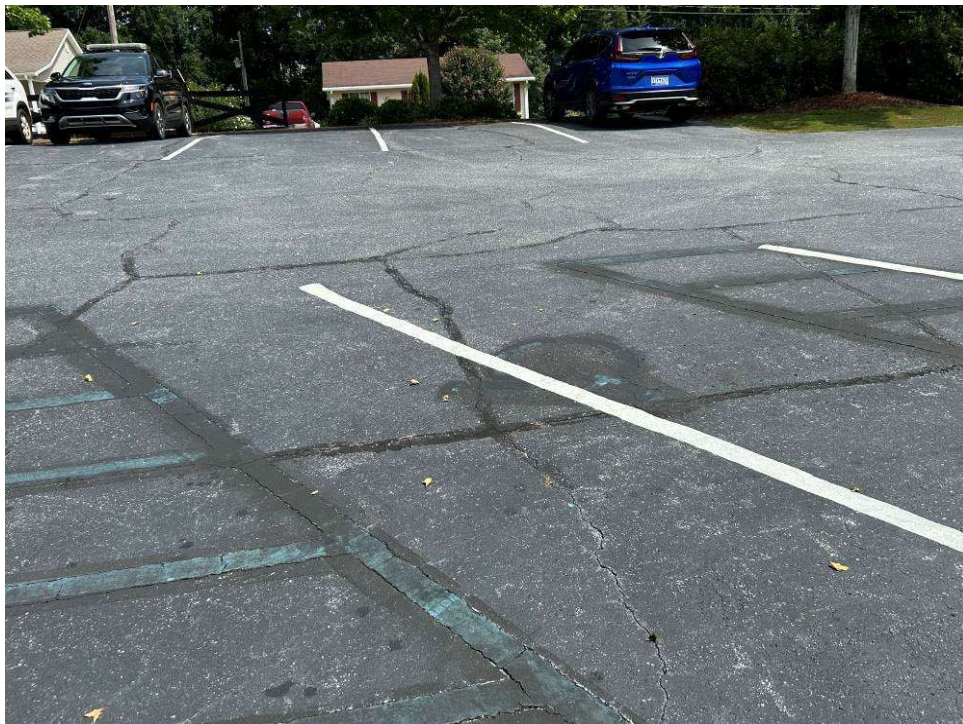
2. View of linear cracks at clubhouse parking lot.

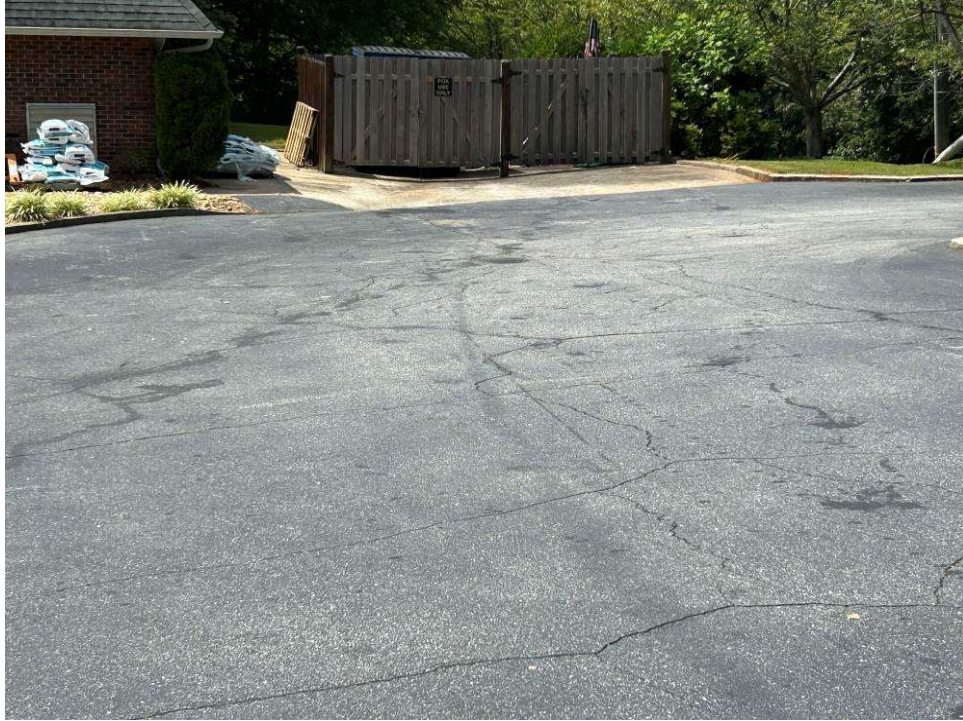
3. View of linear cracks at clubhouse parking lot.

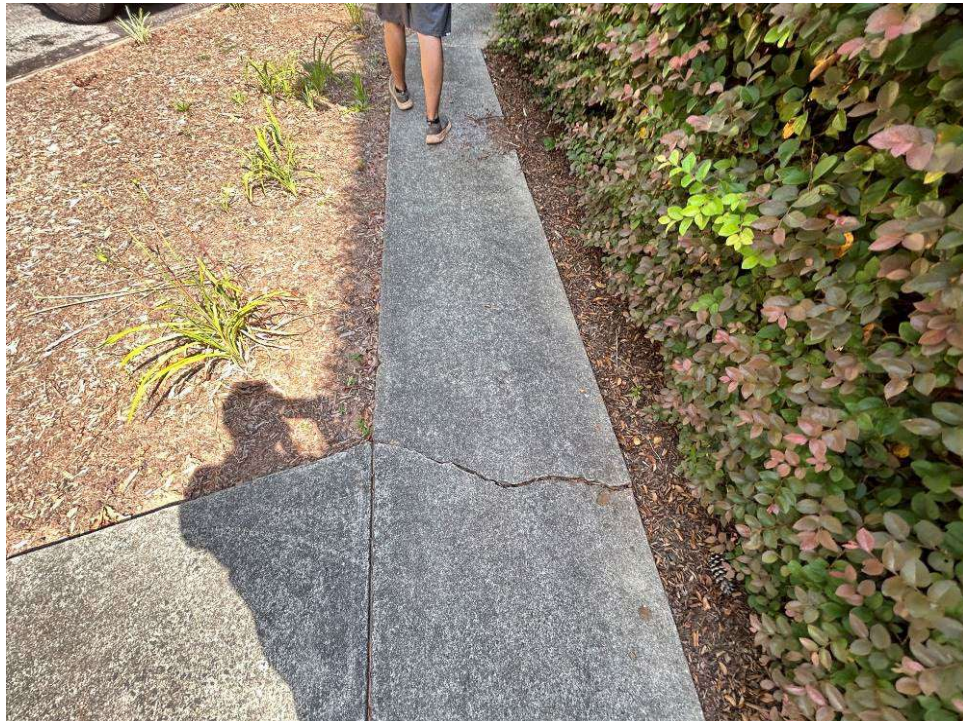
near future. From our review, the curbs and sidewalk appeared to be in generally good condition; however, linear cracks were observed along the curbs and sidewalk (reference photographs 4-7).

4. View of cracked and settled section of sidewalk.

Any sections of sidewalk or curb that are settling should be monitored, and if they continue to settle, these sections should be replaced. The budget is provided for the replacement of damaged, deteriorated, or settled sections of sidewalks and curbs at the property. The budget is provided every six years, and the funding can be used when necessary, during the estimated useful life. The budget is not for complete replacement of the concrete sidewalks or curbs, only replacement of the sections that become trip hazards or safety concerns. Any vertical displacement at cracks that could potentially represent a trip hazard and liability should be replaced. If a tree is uprooting a section of concrete, the tree should be removed and de-rooted before the replacement of the concrete.

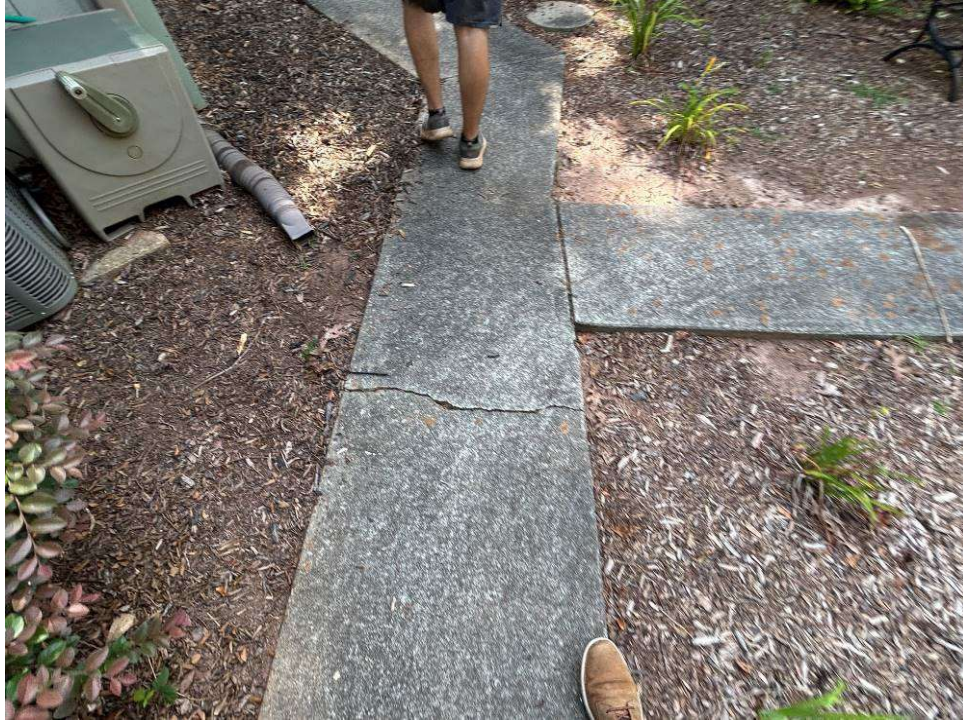
5. View of cracked and settled section of sidewalk.

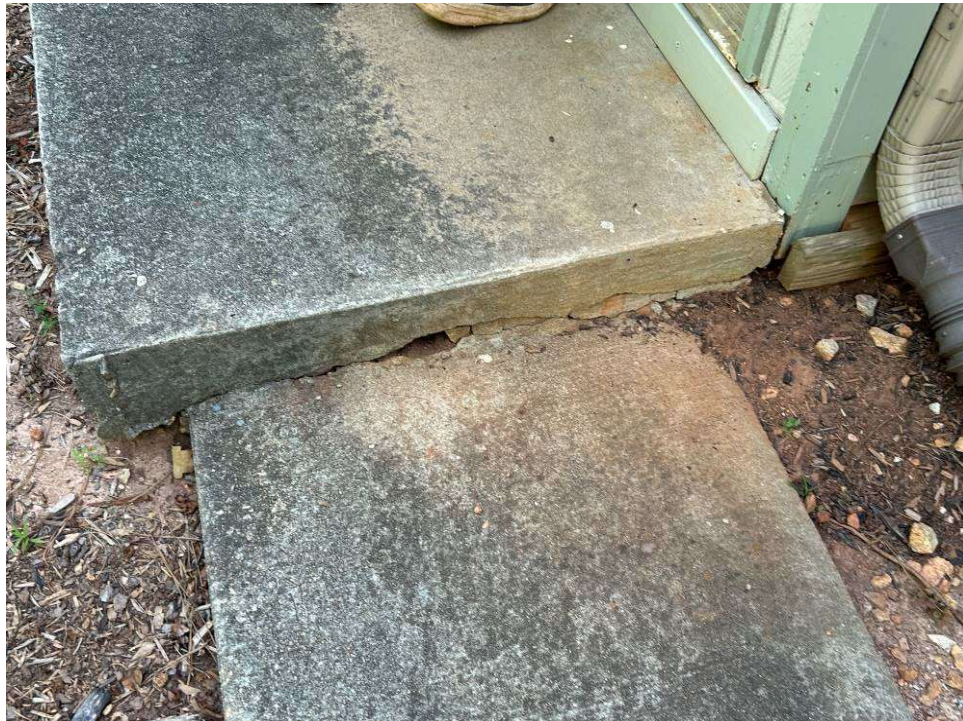
6. View of cracked and settled section of sidewalk.

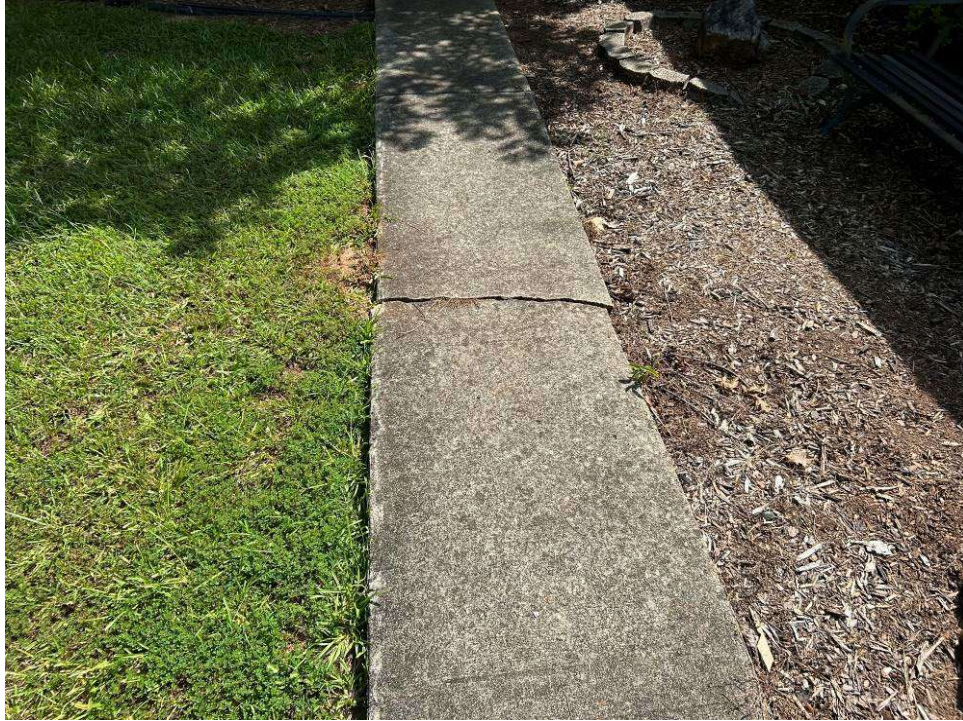
7. View of cracked and settled section of sidewalk.

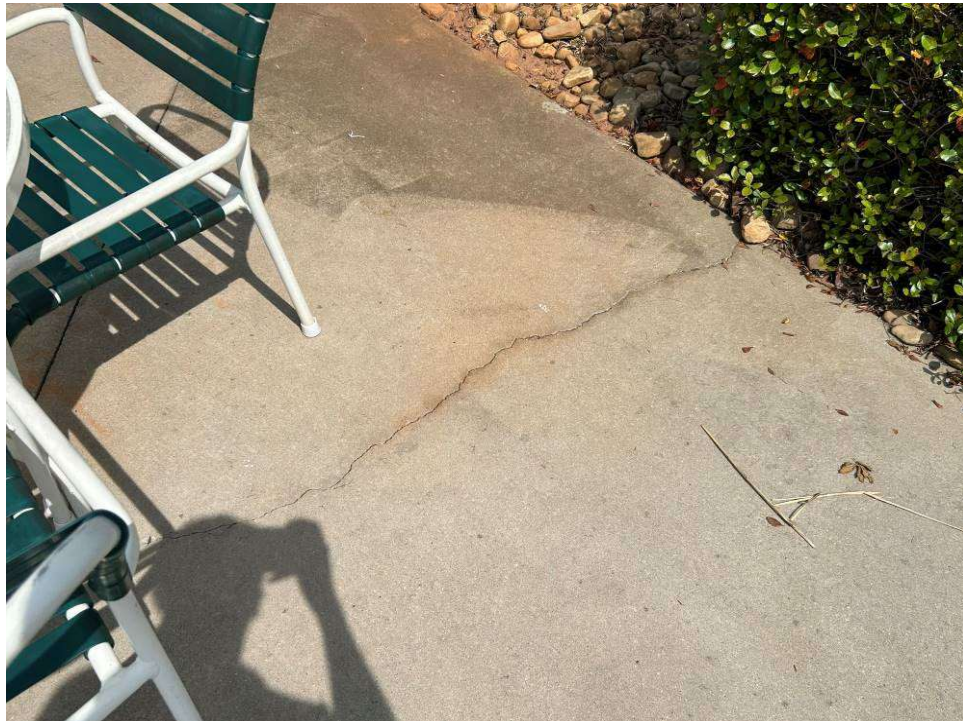
8. View of cracked section of the pool deck.

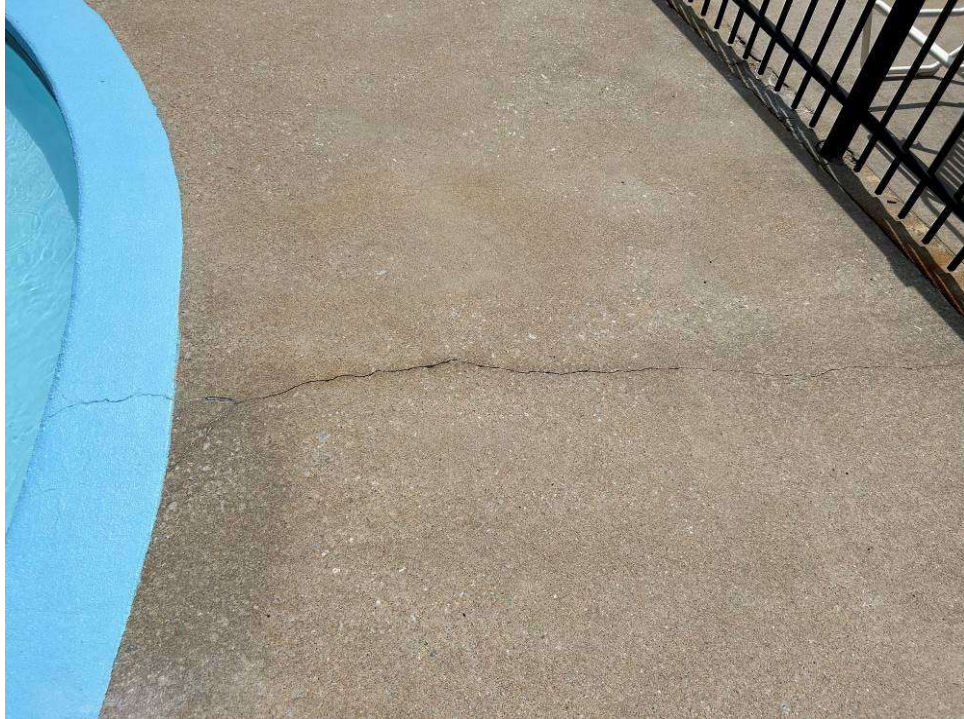
9. View of cracked section of the pool deck.

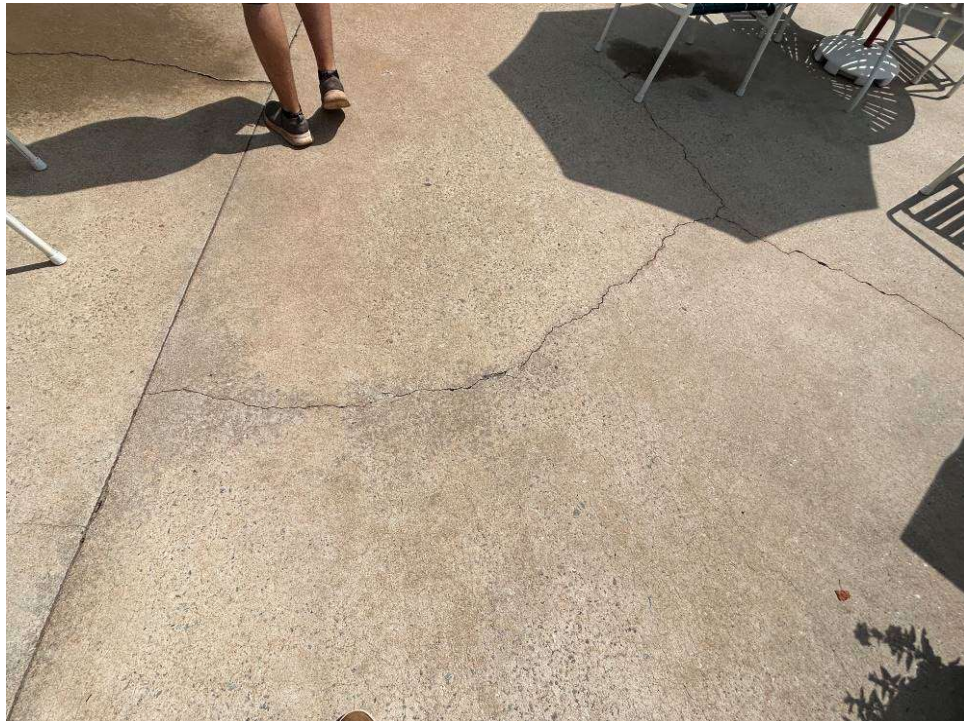
10. View of cracked section of the pool deck.

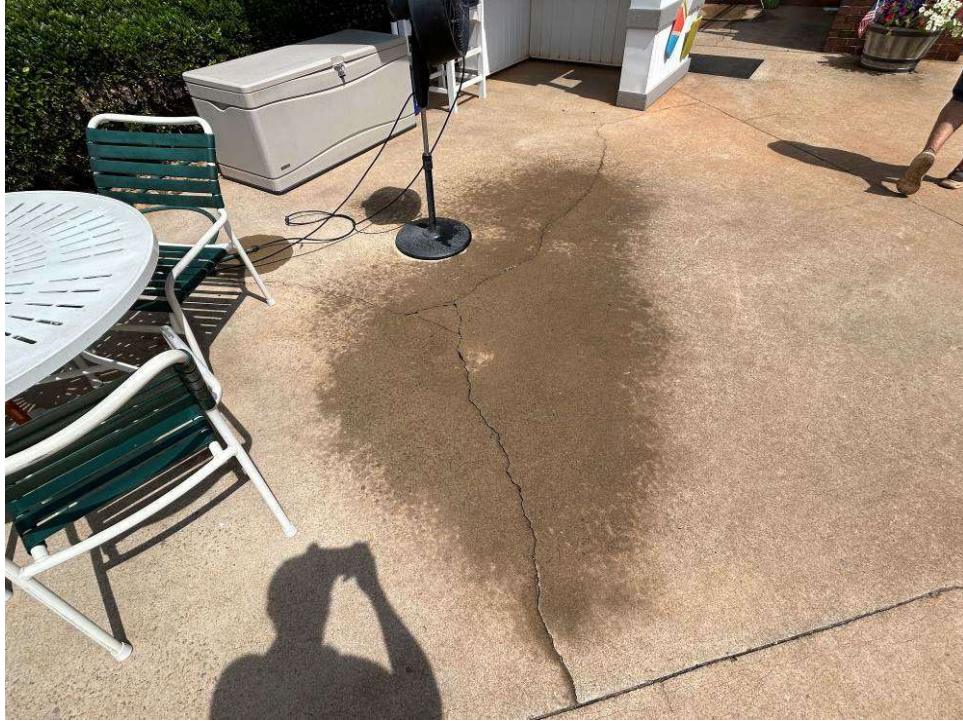
11. View of cracked section of the pool deck.

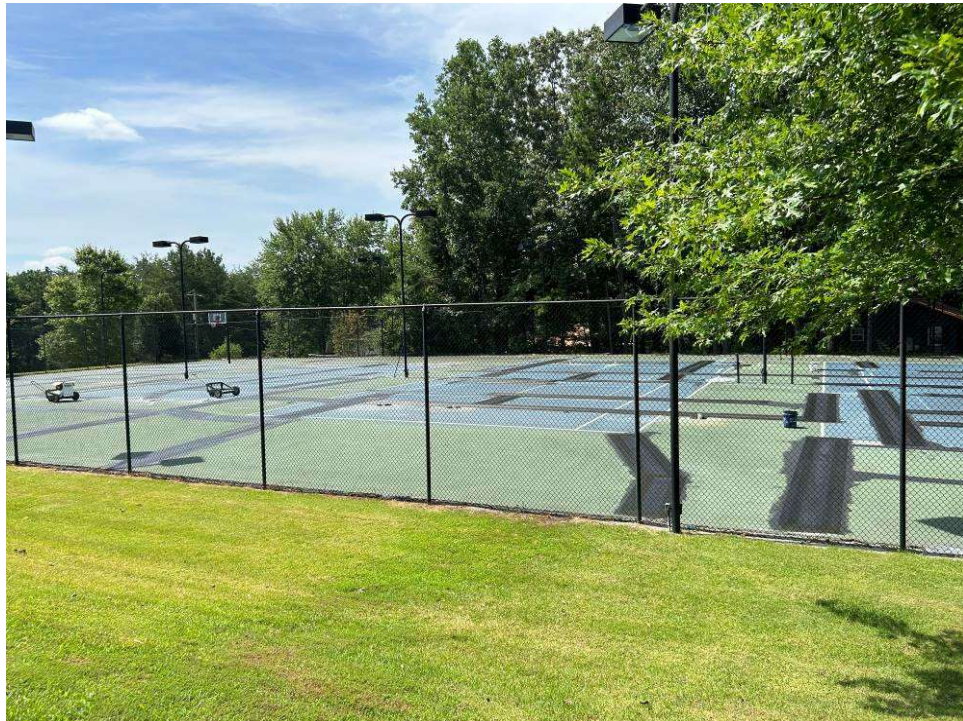
12. View of tennis court being resurfaced.

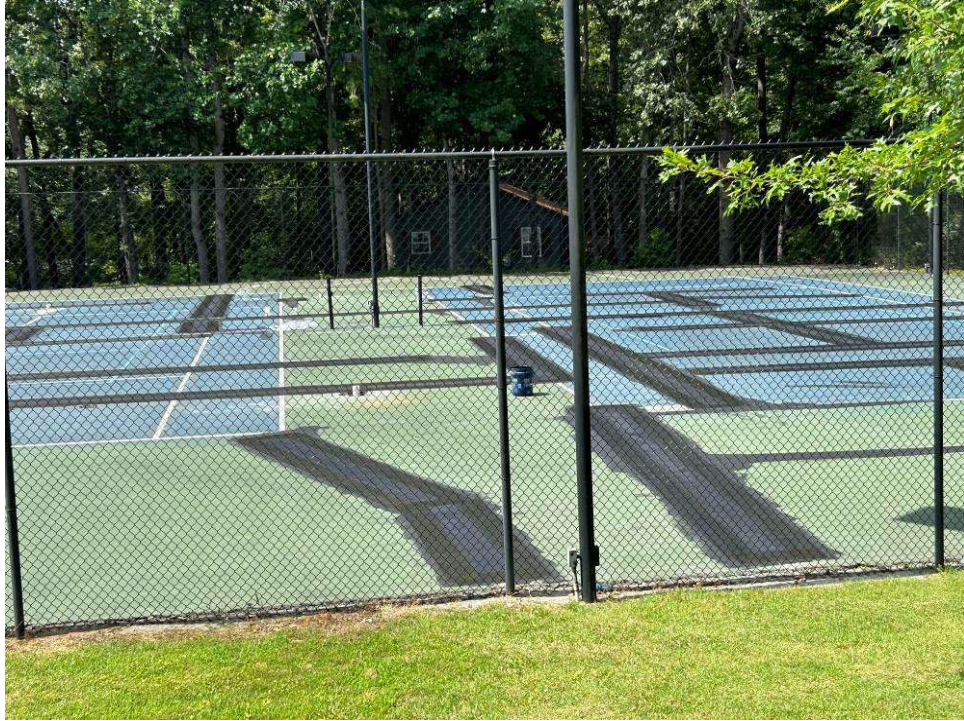
13. View of tennis court being resurfaced.

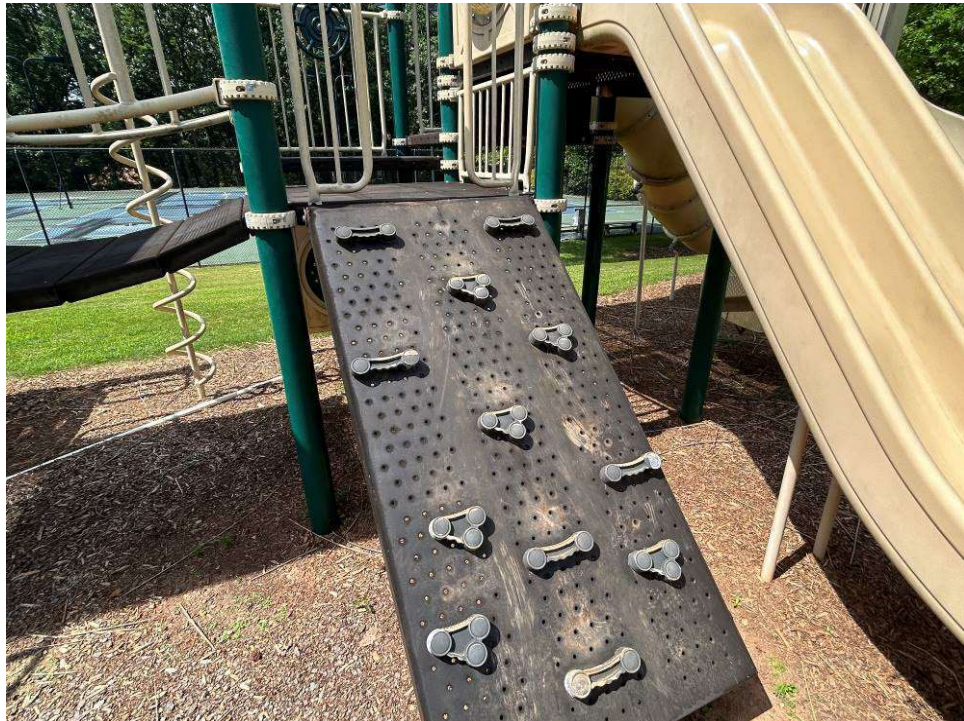
14. View of playground equipment in need of maintenance.

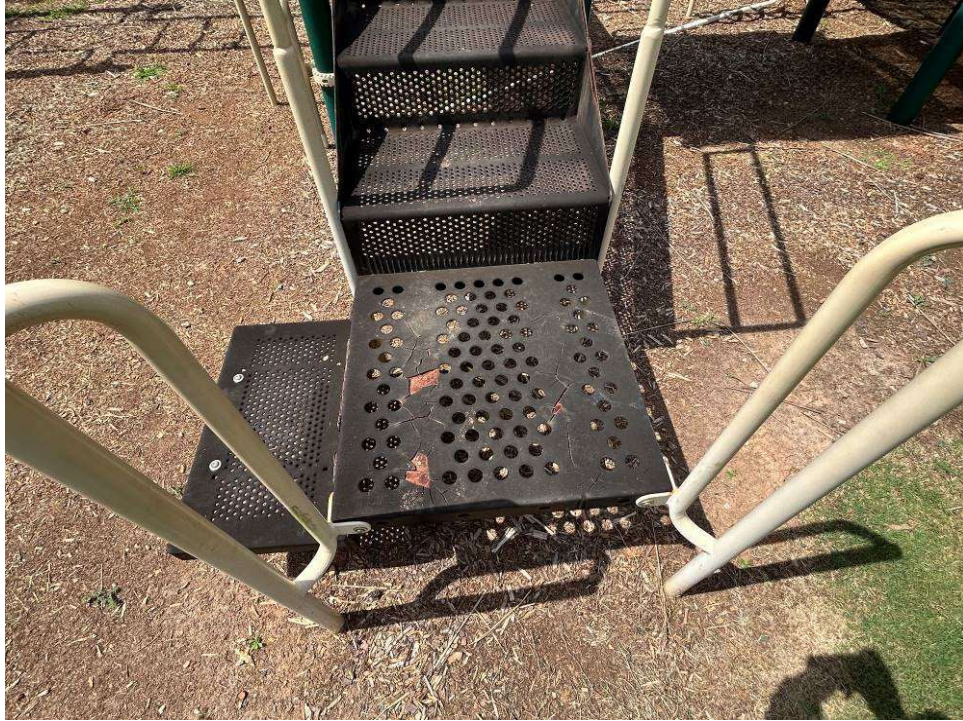
15. View of cracked playground equipment piece.

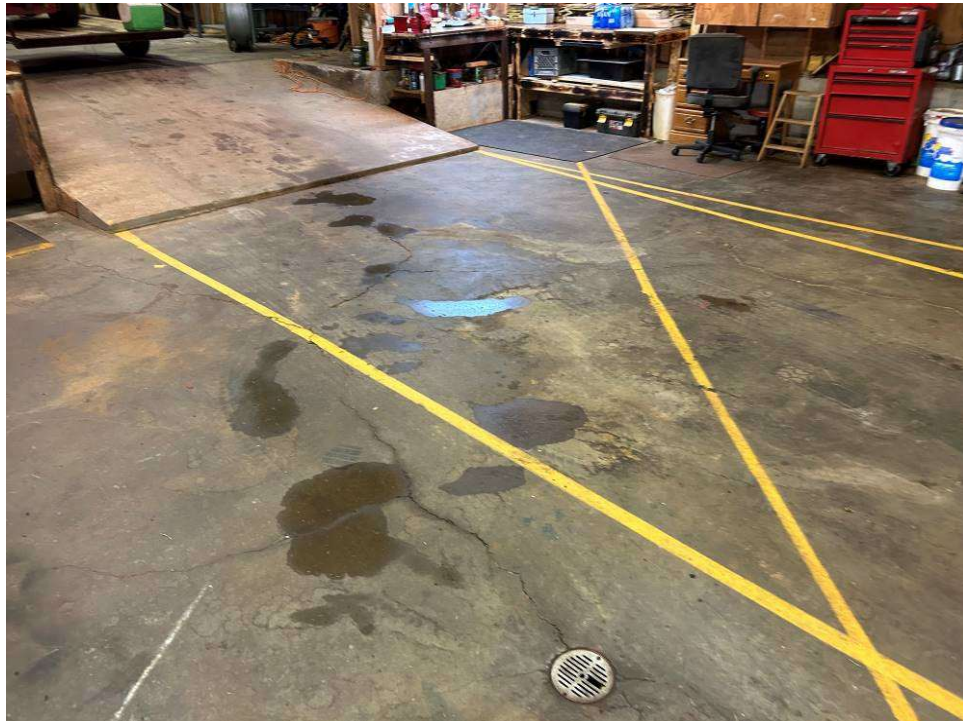
22. View of cracked section of concrete in maintenance building floor.

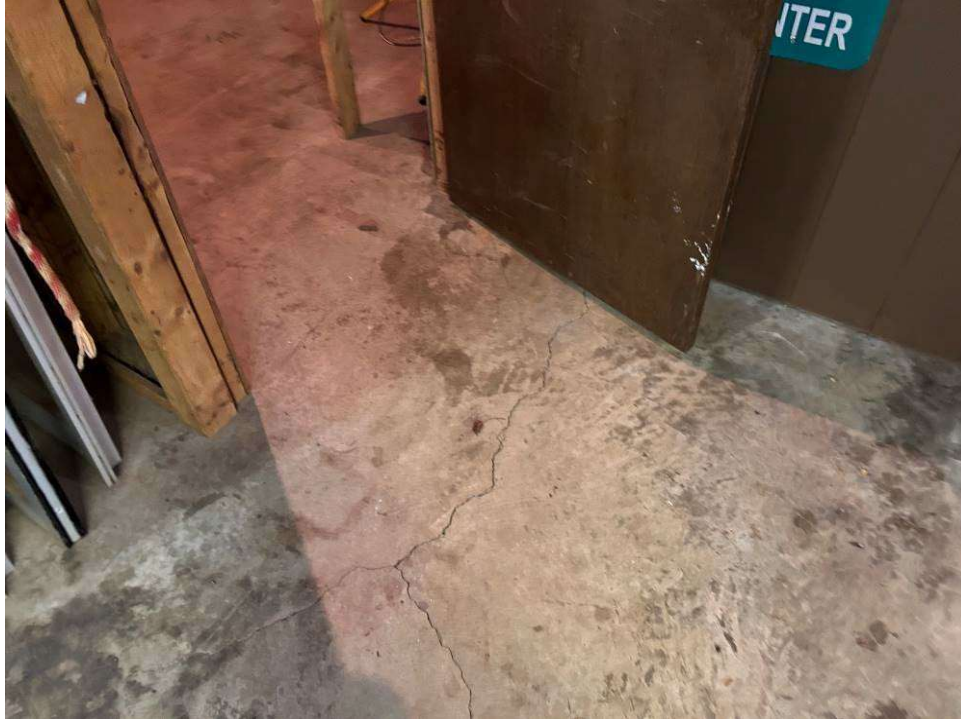
23. View of cracked section of concrete in maintenance building floor.

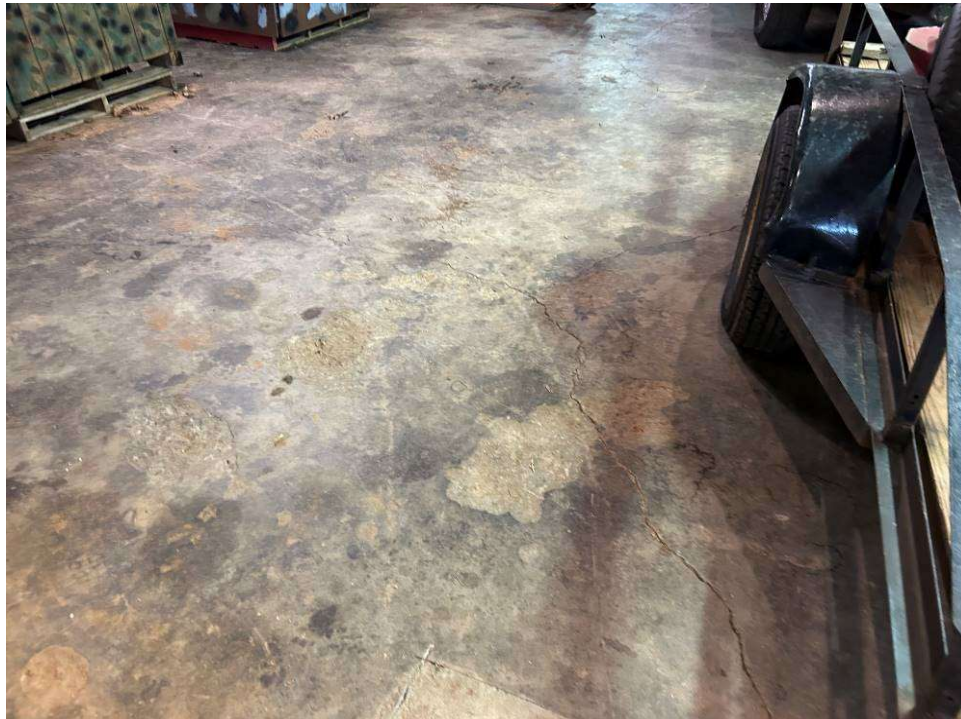
24. View of cracked section of concrete in maintenance building floor.

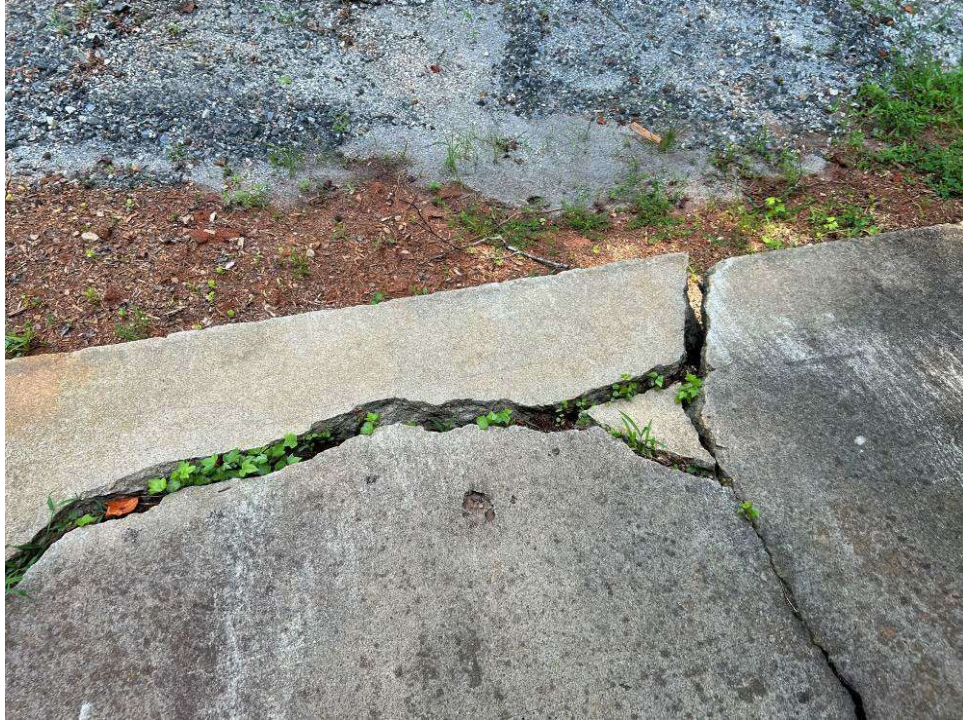
25. View of spalled section of concrete loading dock.

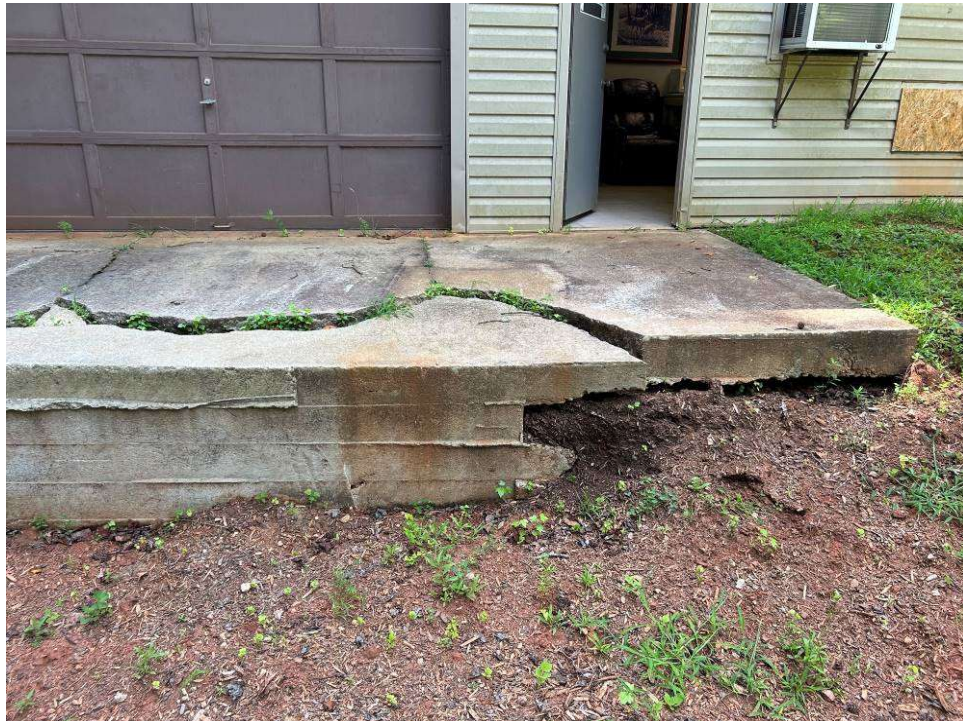
26. View of spalled section of concrete loading dock.

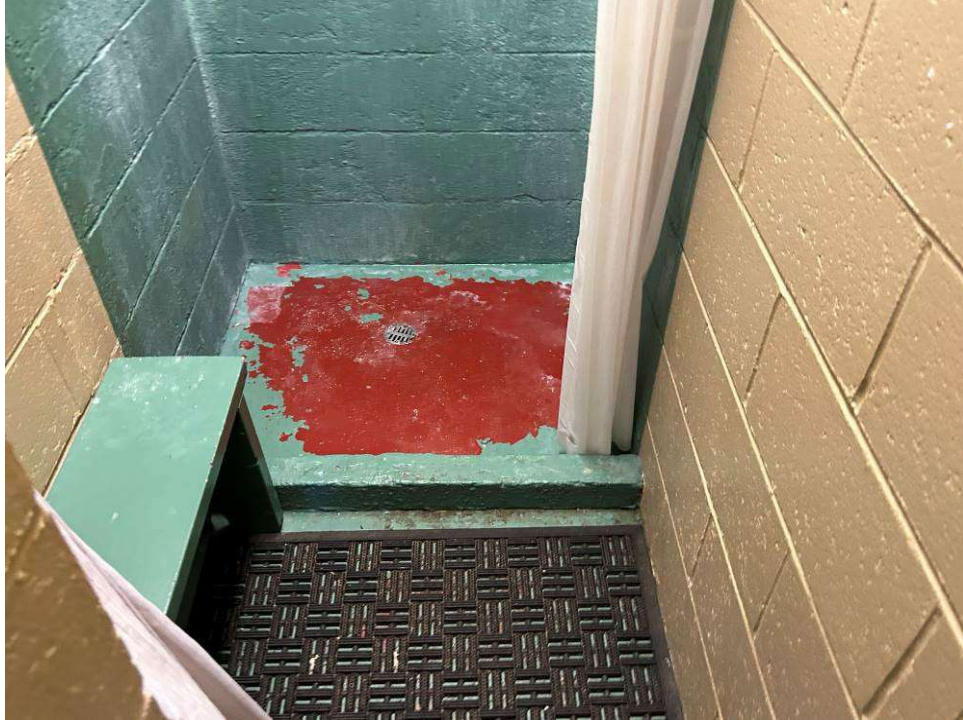
27. View of paint chipping in comfort station bathroom.

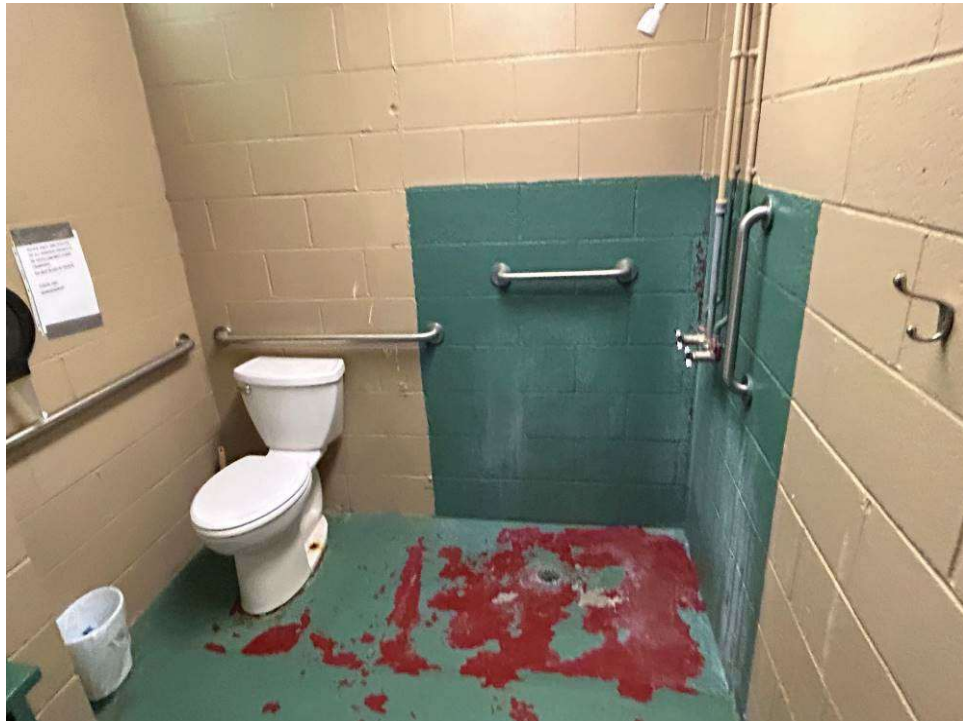
28. View of paint chipping in comfort station bathroom.

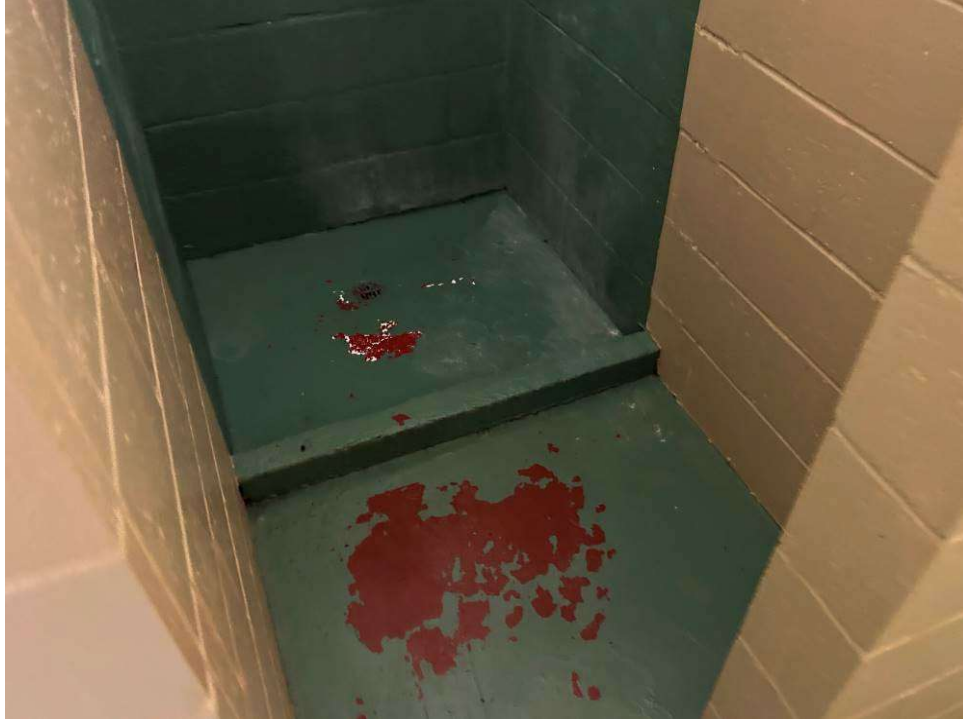
29. View of paint chipping in comfort station bathroom.

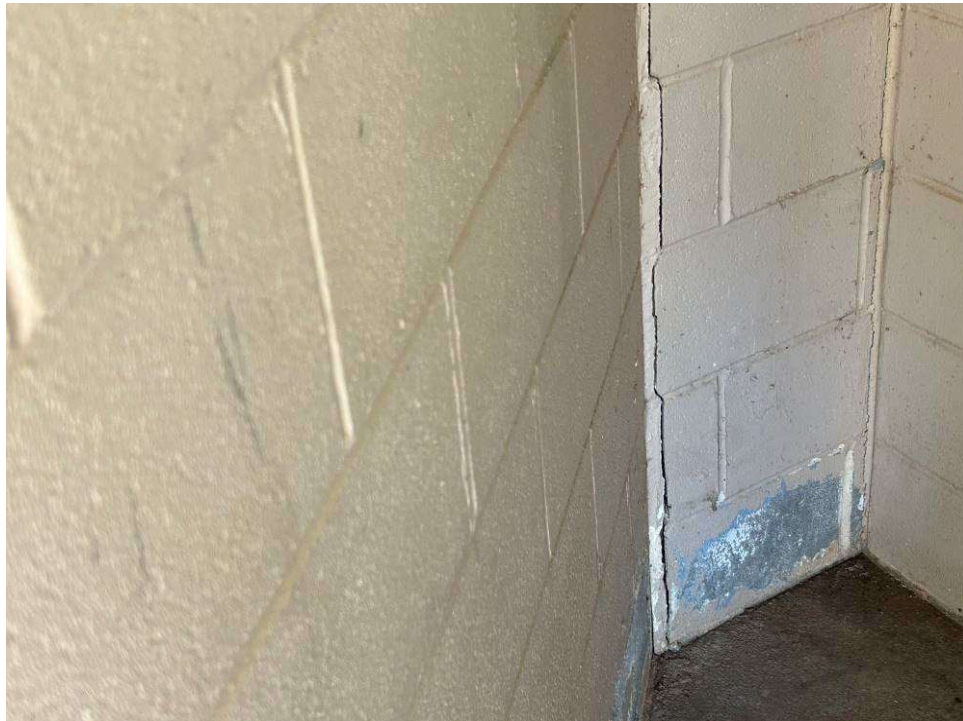
30. View of linear crack in mortar of brick wall at comfort station.

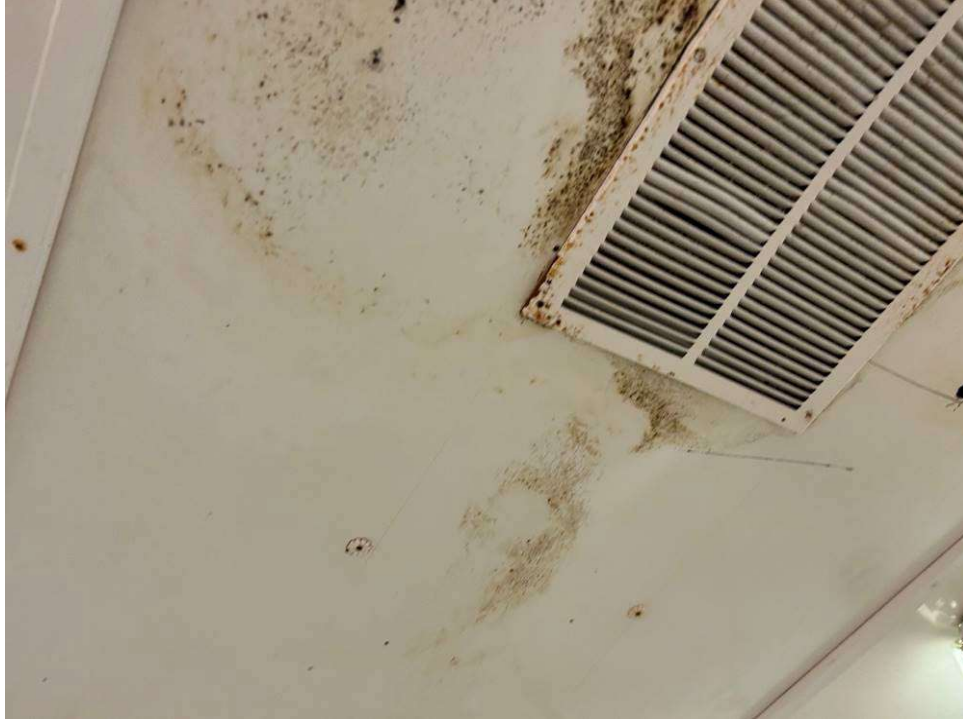
31. View of stains on comfort station bathroom ceiling.

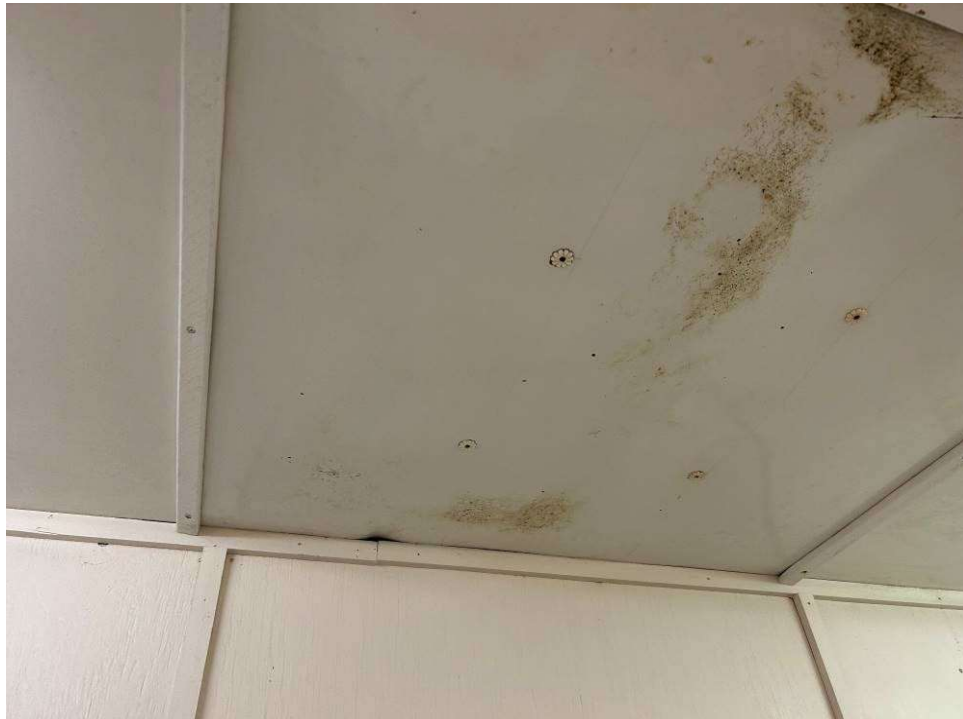
32. View of stains on comfort station bathroom ceiling.
